**Flood Control Project Maintenance  
Levee Inspections****LMA District Cover Sheet  
Spring 2014 Levee Inspection Results****Reclamation District No. 0150 Merrit Island**

**Flood Control Project Maintenance  
Levee Inspections**

**Spring 2014 Levee Inspection Results**

**Reclamation District No. 0150 Merrit Island**

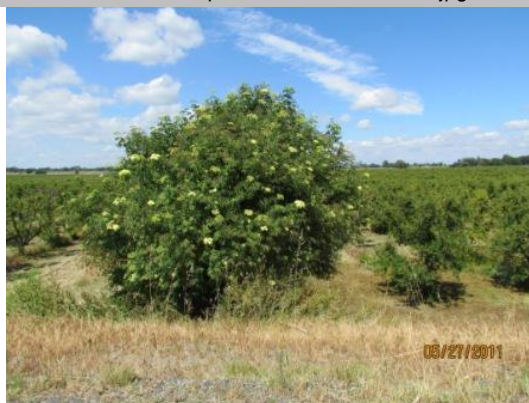
Photo 1 of 1 : pkazi\_s\_20140328\_535.jpg

Elderberry bush was found on the landside of the levee. The picture was taken from the crown looking downstream.

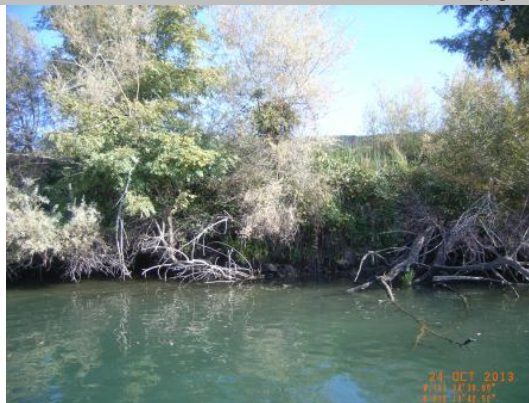
Photo 1 of 2 : USACE2013A\_STR\_28-4\_R\_14.jpg

LM Start	0.44	Rating **	M	Issue No.	2
LM End	0.49	Issue Type +	Ma	Location *	WS
Category	Supplemental			GPS Latitude/Longitude	
				Start	End
Item	USACE Erosion Survey			38.328091 °	38.328606 °
				-121.576640 °	-121.577472 °
DWR ID					
Action/Comments					
Inspector Comments: 2013: Old toe repair unraveling. Bridge at upstream end of site. [2013 Site ID: STR 28-4 R]

USACE 2013 Photo #1

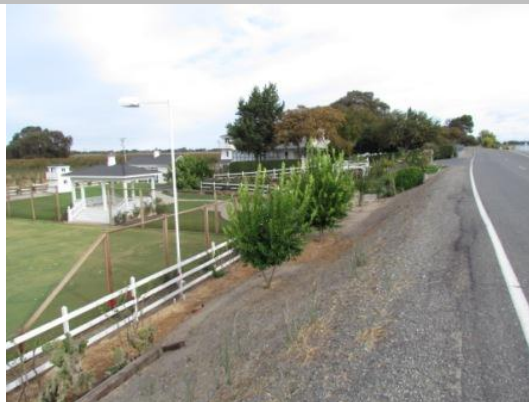
Photo 1 of 1 : pkazi\_s\_20140328\_589.jpg

Landscaping was found on the landside of the levee looking upstream.

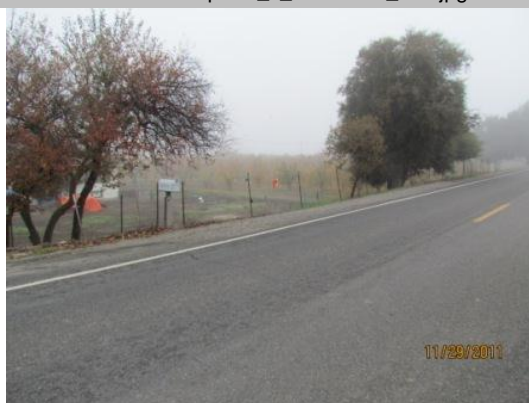
Photo 1 of 1 : pkazi\_s\_20140328\_542.jpg

Fence was found on the landside of the levee looking upstream.

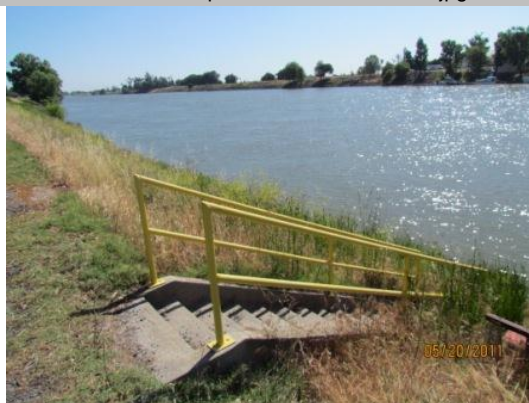
Photo 1 of 1 : pkazi\_s\_20140328\_545.jpg

A stairway was found on the waterside of the levee. The picture was taken from the crown looking upstream.

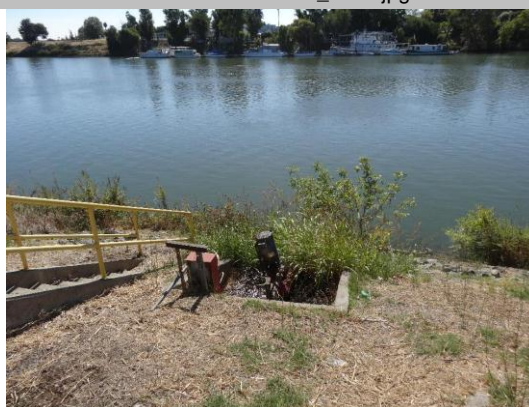
Photo 1 of 1 : UCIP\_2205.jpg

UCIP Comments: - Water leaks from pressure breaker. Distribution box at the landward toe not found/visible. Service pole on LS toe.  
FIELD\_STRUCT\_DESC: 4-inch steel pipe joined to 6-inch steel pipe and the 6-inch pipe joined to 10-inch steel pipe through the levee, 5.8 feet below the crown. 1.5-inch conduit through the levee, 3 feet below the crown. Pump and gate valve on the waterward slope. (Runyon).  
FS Date: 8/27/2013

WS view: walkway/stairs, pump on levee slope.

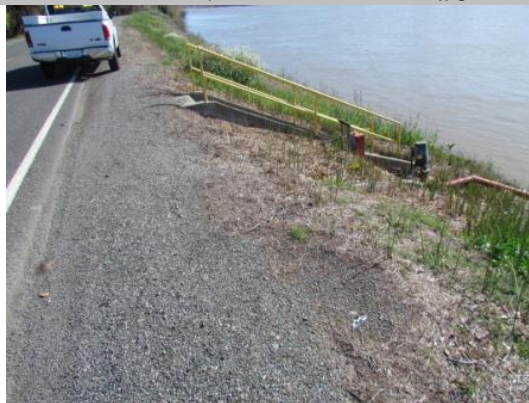
Photo 2 of 2 : pkazi\_s\_20140328\_540.jpg

Slope instability was found on the waterside of the levee looking upstream.

LM Start	0.40	Rating **	M	Issue No.	6
LM End	0.40	Issue Type +	Ma	Location *	WS
Category	Earthen Levee			GPS Latitude/Longitude	
				Start	End
Item	Slope Stability			38.332717 °	38.332717 °
				-121.572083 °	-121.572083 °
DWR ID	DWR_RD0150_02_s _ 2012_6				
Action/Comments					
Repair the levee slope damaged by foot traffic and prevent access where possible.

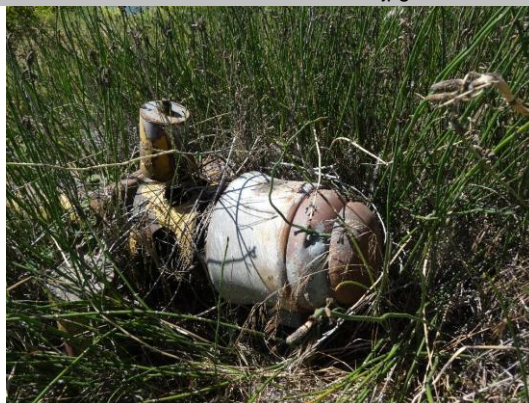
Photo 1 of 1 : UCIP\_2207.jpg

LM Start	0.49	Rating **	M	Issue No.	11
LM End	0.49	Issue Type +	En	Location *	WS
Category	Supplemental			GPS Latitude/Longitude	
				Start	End
Item	DWR UCIP Field Study			38.333754 °	38.333754 °
				-121.571018 °	-121.571018 °
DWR ID	DWR_RD0150_02_s _ 2014_11				
Action/Comments					
Inspector Comments: FS_ID:20284					
EP_NO: N/A					
Repair Type:					
Crossing Status:					
UCIP Comments: Needs proper abandonment.					
FIELD_STRUCT_DESC: 8-inch steel pipe through the levee, 5.7 feet below the crown. Power line on landside.(Mrs. J. Olson) O&M Manual					
SAC 112, March 1957.					
FS Date: 8/27/2013

WS view: abandoned pump on levee slope. Dense vegetation on waterside.

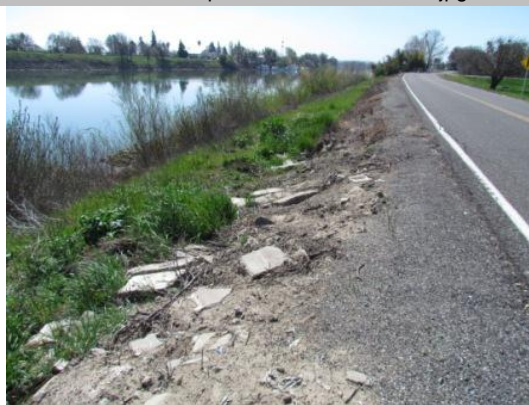
Photo 1 of 1 : pkazi\_s\_20140328\_543.jpg

LM Start	0.70	Rating **	M	Issue No.	10
LM End	0.70	Issue Type +	Ma	Location *	WS
Category	Earthen Levee			GPS Latitude/Longitude	
				Start	End
Item	Encroachments			38.336228 °	38.336228 °
				-121.568332 °	-121.568332 °
DWR ID	DWR_RD0150_02_s _ 2013_10				
Action/Comments					
Debris

Debris was found on the waterside slope of the levee looking downstream during Spring 2013 inspection.

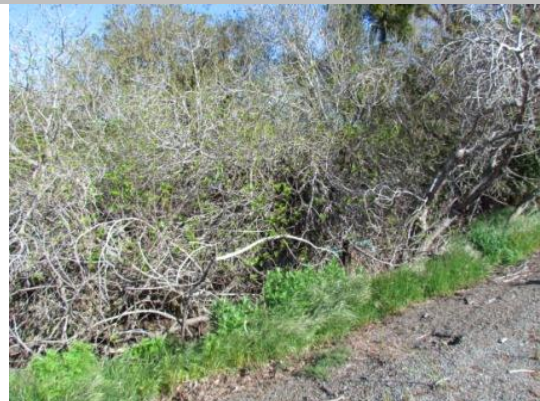
Photo 1 of 1 : pkazi\_s\_20140328\_544.jpg

Overgrown trees were obstructing the landside slope of the levee looking upstream.

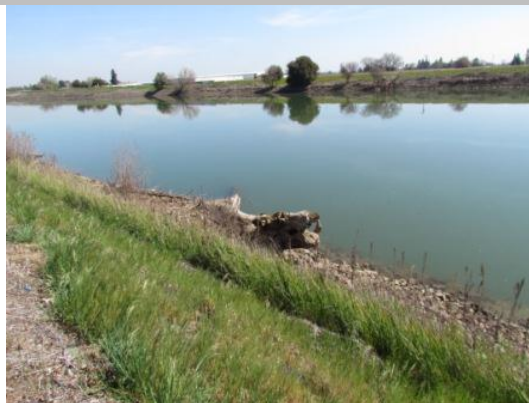
Photo 2 of 2 : pkazi\_s\_20140328\_549.jpg

LM Start	1.00	Rating **	M	Issue No.	18
LM End	1.00	Issue Type +	Ma	Location *	WS
Category	Earthen Levee			GPS Latitude/Longitude	
				Start	End
Item	Encroachments			38.339268 °	38.339268 °
				-121.564839 °	-121.564839 °
DWR ID	DWR_RD0150_02_s _ 2013_18				
Action/Comments					
Tree or limb					
Inspector Comments: Tree trunk was found on the waterside toe of the levee.

A tree trunk was found on the waterside toe of the levee looking upstream during spring 2013 inspection.

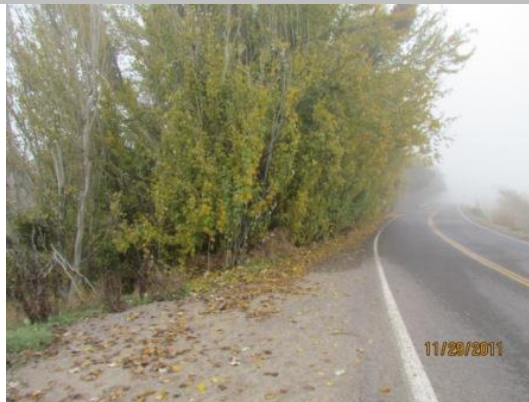
Photo 1 of 2 : pkazi\_s\_20140328\_577.jpg

Landscaping was found landside of the levee looking upstream.

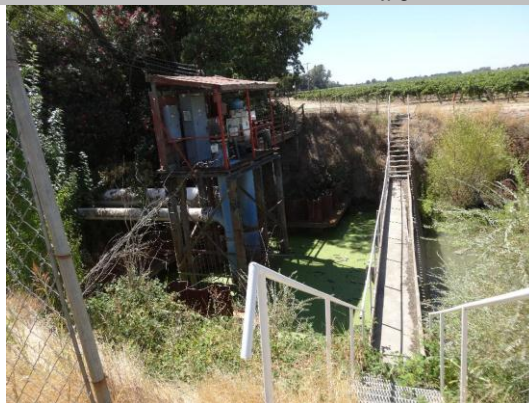
Photo 1 of 1 : UCIP\_2297.jpg

UCIP Comments: Pump house and drainage ditch about 250 feet from the levee on landside. Pumps on piling structure with shed in drainage ditch. Siphon breaker cover missing. Needs to fix it.

LS view: pipe, walkway, and pump structure in drainage ditch.

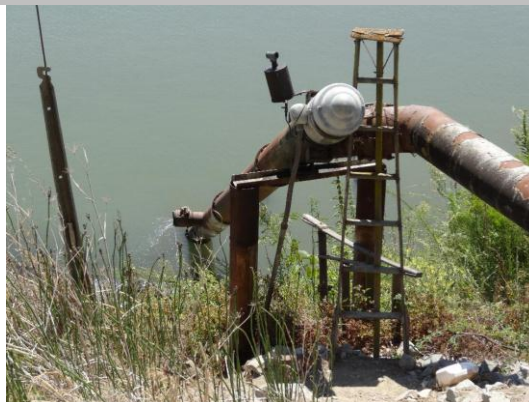
Photo 1 of 1 : UCIP\_2301.jpg

UCIP Comments: - Operating during inspection. Leaky join at the concrete box. Power overhead crossing. Power pole at waterside shoulder, and landside toe.

WS view: slant pump on steel frame support and exposed pipe on levee slope.

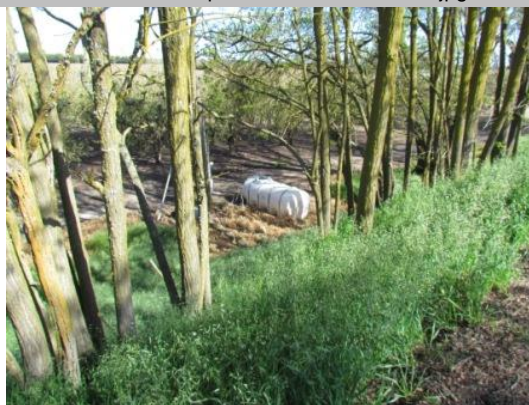
Photo 1 of 1 : pkazi\_s\_20140328\_551.jpg

LM Start	2.75	Rating **	M	Issue No.	23
LM End	2.75	Issue Type +	En	Location *	LS
Category	Earthen Levee			GPS Latitude/Longitude	
				Start	End
Item	Encroachments			38.349542 °	38.349542 °
				-121.537451 °	-121.537451 °
DWR ID	DWR_RD0150_02_s _ 2012_23				
Action/Comments					
Tank					
Inspector Comments: Tank was found with the 10 feet of toe landside easement.

A tank was found on the landside toe of the levee looking upstream.

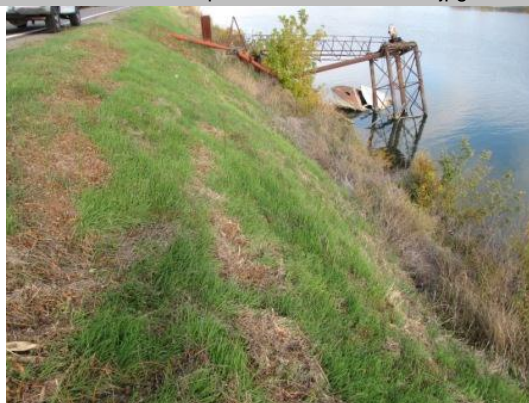
Photo 1 of 6 : pkazi\_s\_20140328\_580.jpg

LM Start	3.29	Rating **	M	Issue No.	961
LM End	3.29	Issue Type +	Ma	Location *	WS
Category	Earthen Levee			GPS Latitude/Longitude	
				Start	End
Item	Erosion / Bank Caving			38.355321 °	38.355321 °
				-121.530902 °	-121.530902 °
DWR ID	DWR_RD0150_02_s _ 2012_961				
Action/Comments					
Schedule repair of erosion site prior to the next inspection. Inspector Comments: Depressions into the waterward slope can be seen along the waterward slope at this site. Also note the damaged pump support, pump, and pipe just upstream of the site; they may contribute to the erosion in a high water event and should be removed.

View of erosion on the waterward slope looking upstream. Depressions into the slope can be seen in several places.

LM Start	3.29	Rating **	M	Issue No.	961 (cont)	
LM End	3.29	Issue Type +	Ma	Location *	WS	
Category	Earthen Levee			GPS Latitude/Longitude		
				Start	End	
Item	Erosion / Bank Caving			38.355321 °	38.355321 °	
				-121.530902 °	-121.530902 °	
DWR ID	DWR_RD0150_02_s _ 2012_961					
Action/Comments						
Schedule repair of erosion site prior to the next inspection.

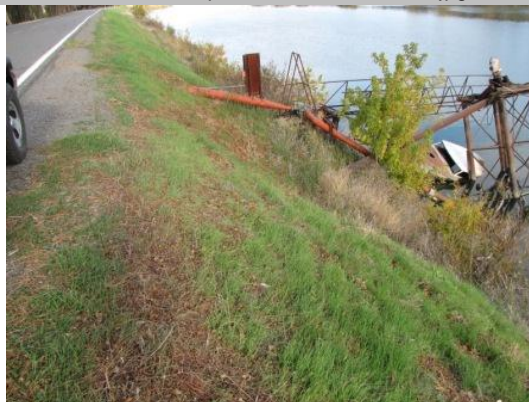
Photo 2 of 6 : pkazi\_s\_20140328\_581.jpg

Additional view of erosion on the waterward slope looking upstream. Note the damaged pump support, pump, and pipe just upstream of the site.

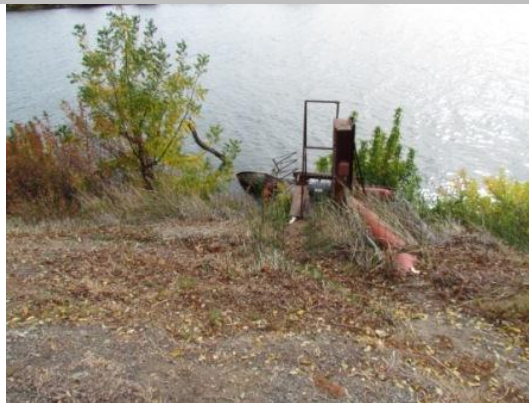
Photo 4 of 6 : pkazi\_s\_20140328\_583.jpg

View of erosion and damaged pipe and abandoned boat on the waterside of the levee looking upstream. This picture was taken during fall 2012 inspection.

LM Start	3.29	Rating **	M	Issue No.	961 (cont)	
LM End	3.29	Issue Type +	Ma	Location *	WS	
Category	Earthen Levee			GPS Latitude/Longitude		
				Start	End	
Item	Erosion / Bank Caving			38.355321 °	38.355321 °	
				-121.530902 °	-121.530902 °	
DWR ID	DWR_RD0150_02_s _ 2012_961					
Action/Comments						
Schedule repair of erosion site prior to the next inspection.

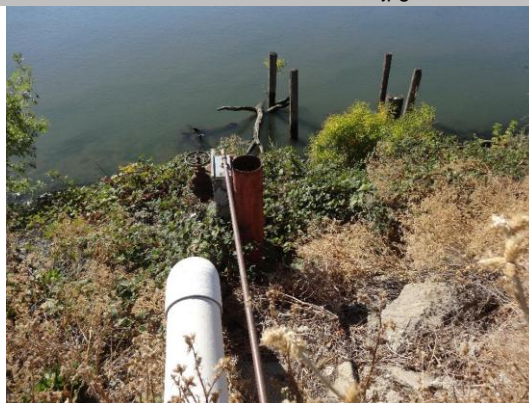
Photo 1 of 1 : UCIP\_2134.jpg

LM Start	3.56	Rating **	M	Issue No.	35
LM End	3.56	Issue Type +	En	Location *	LS
Category	Supplemental			GPS Latitude/Longitude	
				Start	End
Item	DWR UCIP Field Study			38.358094 °	38.358094 °
				-121.527618 °	-121.527618 °
DWR ID	DWR_RD0150_02_s _ 2014_35				
Action/Comments					
Inspector Comments: FS_ID:19846					
EP_NO: N/A					
Repair Type:					
Crossing Status:					
UCIP Comments: - 8" pvc pipe sleeved into 12" steel pipe.needs filling/grouting in gas between 8" pvc pipe and 12" steel pipe on WS.					
1.5" electric conduit on WS10" steel pipe extended to 8" pvc pipe on landside levee toe.					
FIELD_STRUCT_DESC: 12-inch steel pipe through the levee, 3.0 feet below the crown, pump and gate valve on the waterward slope. (R & J Pylman). O&M Manual SAC 112, March 1957.					
FS Date: 8/30/2013

WS view: pipe, pump, and conduit on levee slope.

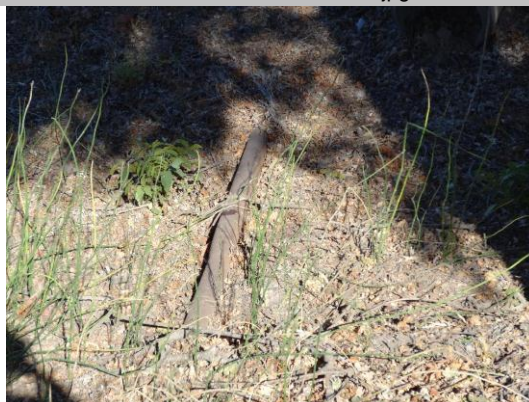
Photo 1 of 1 : UCIP\_2137.jpg

LM Start	3.56	Rating **	M	Issue No.	36
LM End	3.56	Issue Type +	En	Location *	CR
Category	Supplemental			GPS Latitude/Longitude	
				Start	End
Item	DWR UCIP Field Study			38.358131 °	38.358131 °
				-121.527540 °	-121.527540 °
DWR ID	DWR_RD0150_02_s _ 2014_36				
Action/Comments					
Inspector Comments: FS_ID:19848					
EP_NO: N/A					
Repair Type:					
Crossing Status:					
UCIP Comments: - needs proper abandonment.					
FIELD_STRUCT_DESC: Abandoned 4-inch steel pipe on landward					
slope. 1-inch steel conduit on waterward slope found.					
FS Date: 8/30/2013

LS view: abandoned 4-inch steel pipe on levee slope.

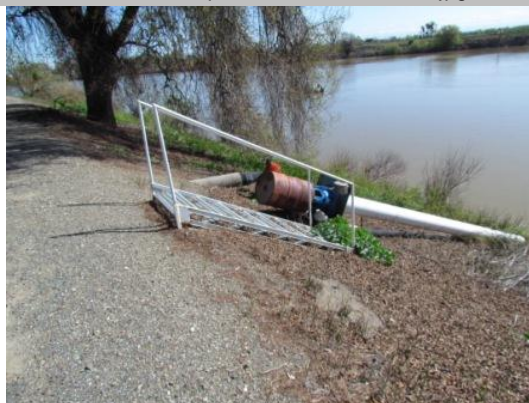
Photo 1 of 1 : pkazi\_s\_20140328\_557.jpg

A stairway was found on the waterside slope of the levee.

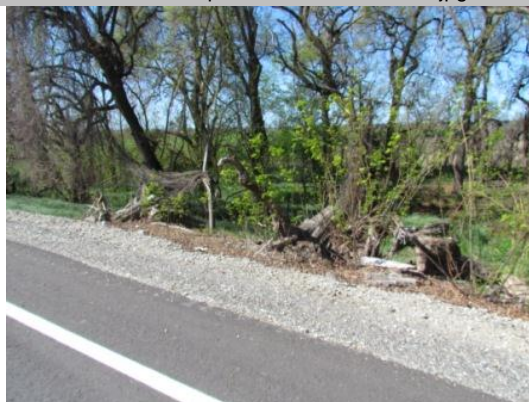
Photo 1 of 1 : pkazi\_s\_20140328\_560.jpg

Tree stumps were found on the landside of the levee looking from the crown.

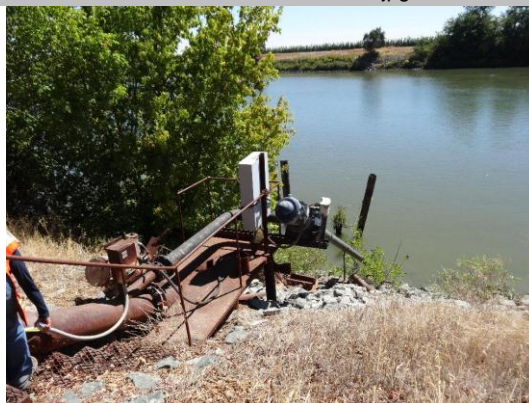
Photo 1 of 1 : UCIP\_2316.jpg

WS view: pipe, walkway, slant pump &amp; pump platform on stream bank.

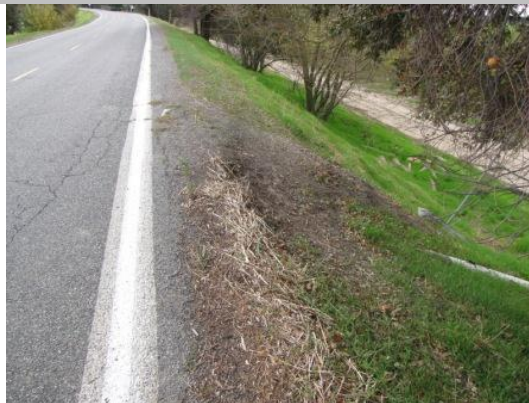
Photo 1 of 2 : pkazi\_s\_20140328\_586.jpg

View of a minor depression along the landward slope of the levee over a pipe penetration looking downstream.

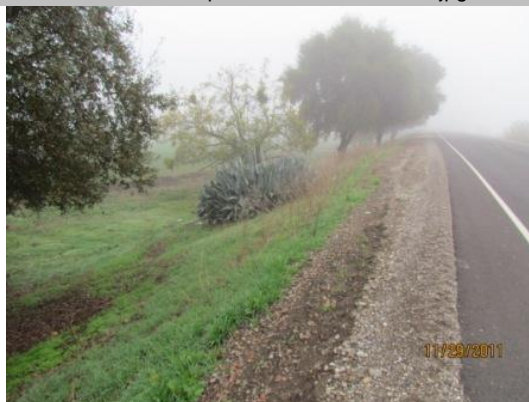
Photo 1 of 1 : pkazi\_s\_20140328\_553.jpg

Century plant was found on the landside of the levee looking upstream.

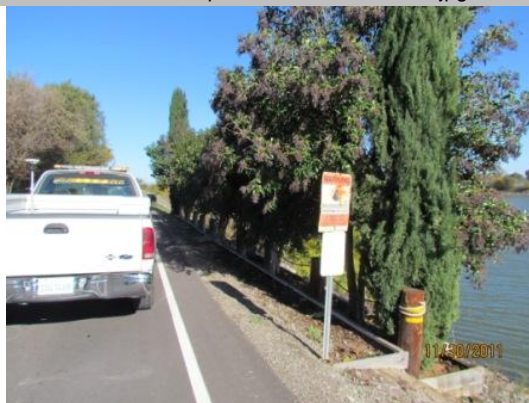
Photo 1 of 1 : pkazi\_s\_20140328\_558.jpg

Landscaping was found on the waterside of the levee looking upstream.

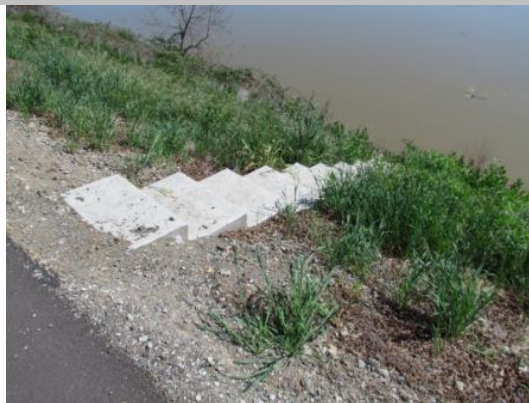
Photo 1 of 1 : pkazi\_s\_20140328\_561.jpg

A stairway was found on the waterside slope of the levee looking upstream.

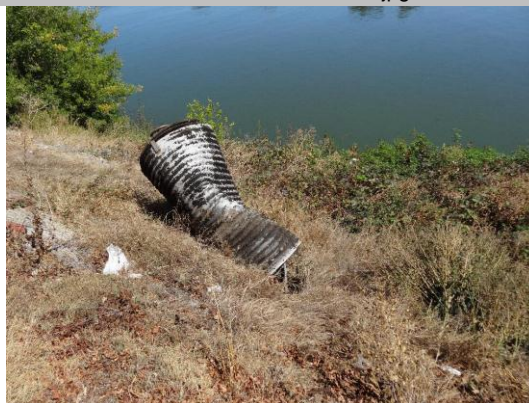
Photo 1 of 1 : UCIP\_2331.jpg

WS view: an abandoned and dismantled CMP riser on WS levee slope.

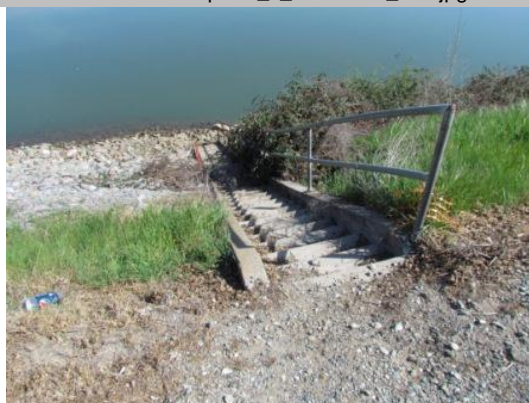
Photo 1 of 1 : pkazi\_s\_20140328\_559.jpg

A stair was found on the waterside slope of the levee looking upstream during spring 2013 inspection.

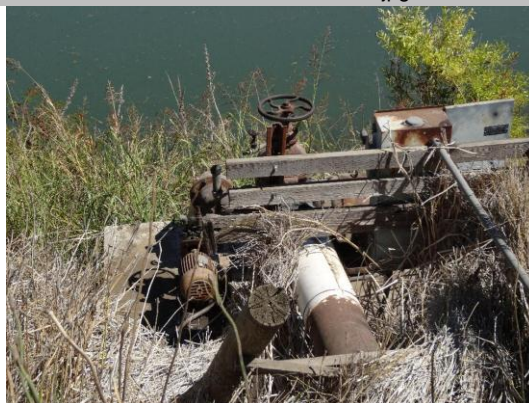
Photo 1 of 1 : UCIP\_2334.jpg

WS view: steel pipe, electric conduit, gate valve, and pump on levee slope.

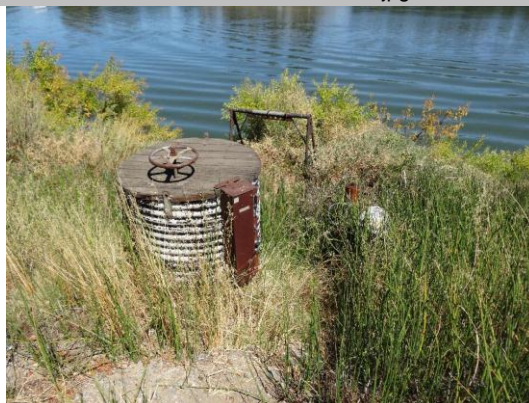
Photo 1 of 1 : UCIP\_2194.jpg

WS view: CMP riser with slide gate and pump (right) on levee slope.

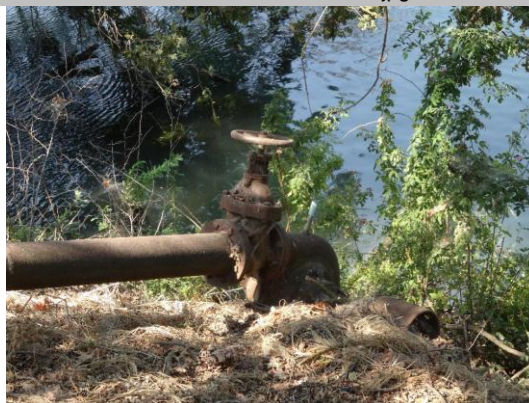
Photo 1 of 1 : UCIP\_1780.jpg

WS view: pipe and pump on levee slope.

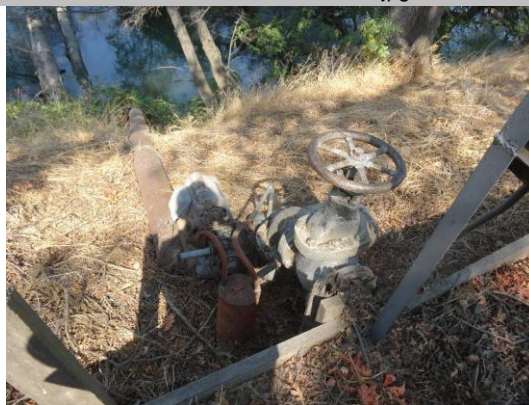
Photo 1 of 1 : UCIP\_1777.jpg

WS view: pipe, gate valve, and pump on levee slope.

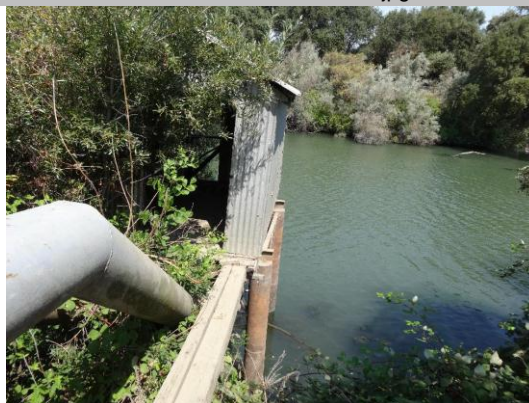
Photo 1 of 1 : UCIP\_1785.jpg

WS view: pipe, wooden walkway and pump house in channel.

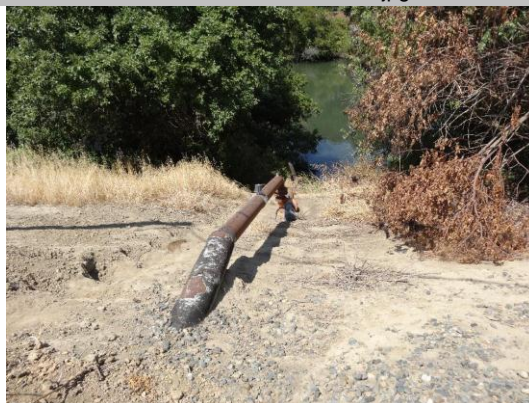
Photo 1 of 1 : UCIP\_1792.jpg

WS view: exposed pipe on levee slope.

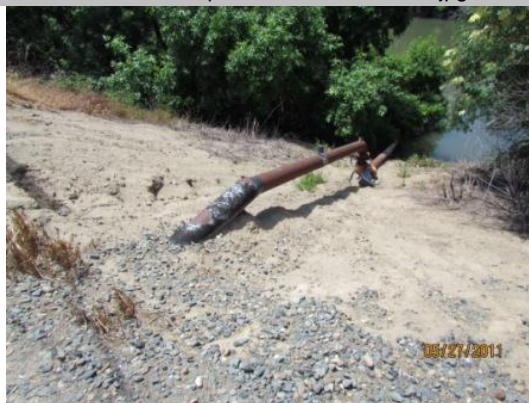
Photo 1 of 2 : pkazi\_s\_20140328\_648.jpg

Erosion was found on the waterside slope of the levee near the vicinity of the pipe. The picture was taken from the crown looking downstream.

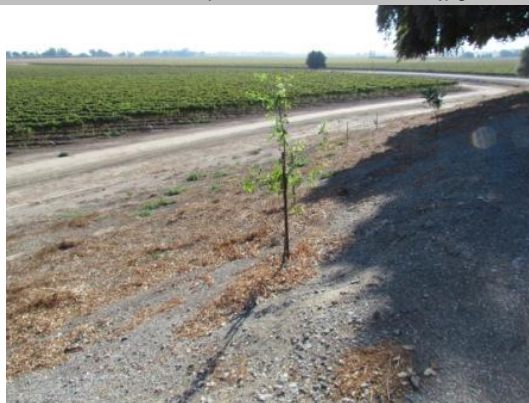
Photo 3 of 5 : pkazi\_s\_20140328\_683.jpg

New tree was found on the landside shoulder of the levee looking downstream. This picture was taken during fall 2012 inspection.

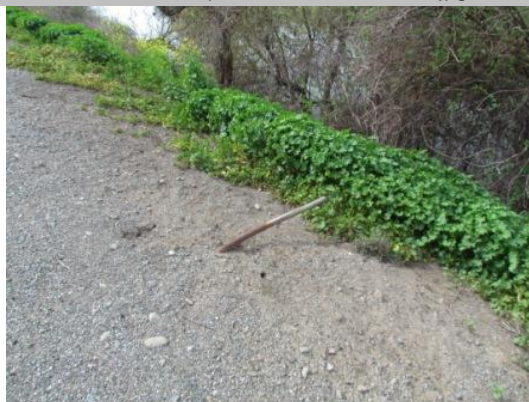
Photo 1 of 1 : pkazi\_s\_20140328\_634.jpg

A pipe was found on the waterside shoulder of the levee looking downstream during spring 2013 inspection.

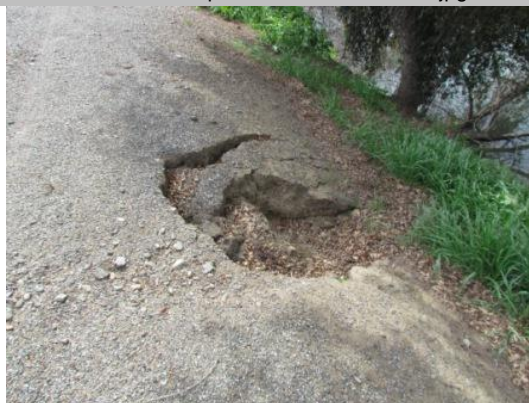
Photo 2 of 2 : pkazi\_s\_20140328\_635.jpg

Erosion was found on the waterside slope of the levee looking downstream during spring 2013 inspection.

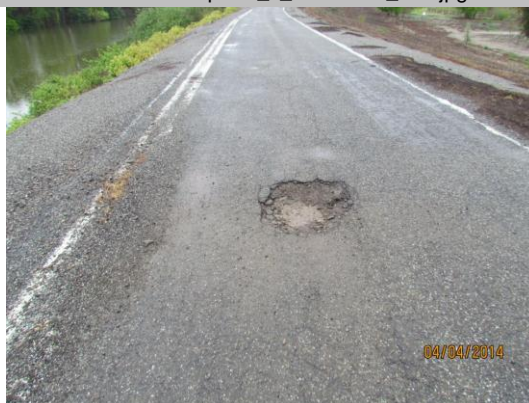
Photo 1 of 1 : pkazi\_s\_20140404\_074.jpg

A crown depression was found looking upstream.

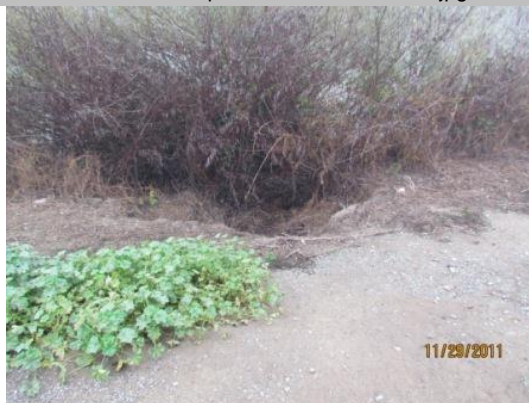
Photo 1 of 2 : pkazi\_s\_20140328\_678.jpg

Slope instability was found on the waterside of the levee. The picture was taken from the crown looking towards the toe of the levee.

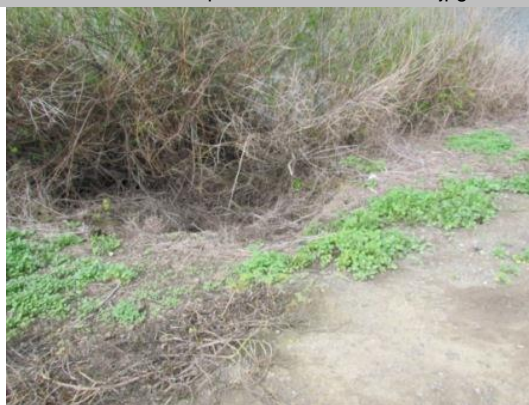
Photo 2 of 2 : pkazi\_s\_20140328\_679.jpg

Erosion was found on the waterside of the levee looking upstream. This picture was taken during spring 2012 inspection.

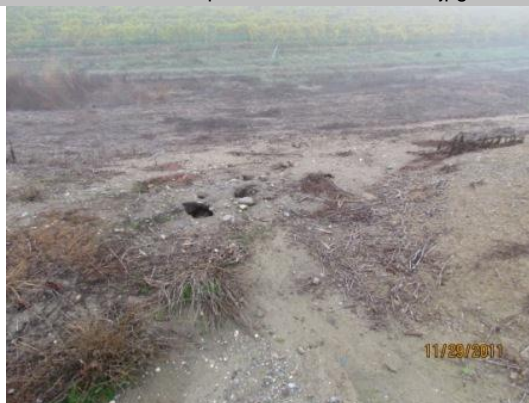
Photo 3 of 3 : pkazi\_s\_20140328\_674.jpg

Rodent holes were found on the landside of the levee looking downstream.

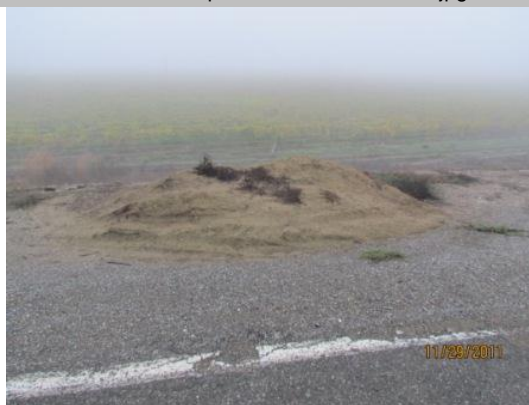
Photo 1 of 1 : pkazi\_s\_20140328\_676.jpg

Material was found on the landside of the levee looking downstream.

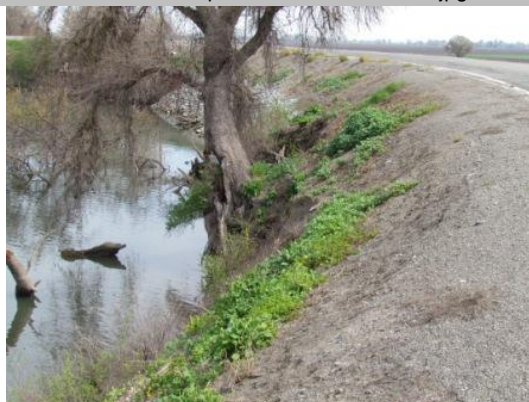
Photo 1 of 1 : pkazi\_s\_20140328\_639.jpg

Erosion was found on the waterside toe of the levee looking upstream during spring 2013 inspection.

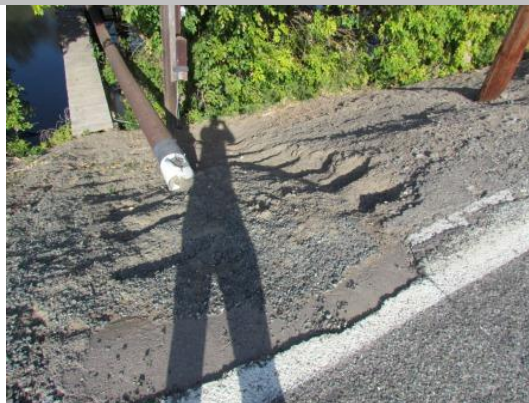
Photo 1 of 1 : pkazi\_s\_20140328\_695.jpg

Steps were dug on the waterside slope of the levee looking upstream.

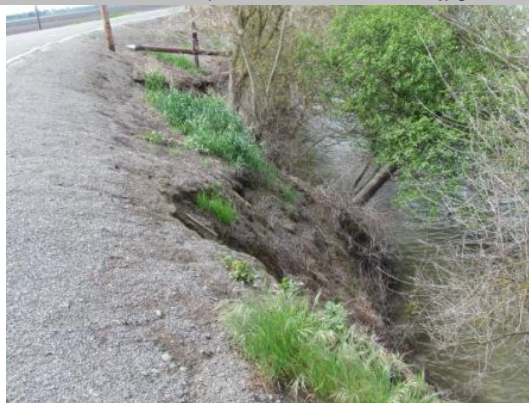
Photo 1 of 1 : pkazi\_s\_20140328\_692.jpg

Erosion was found on the waterside of the levee looking downstream.

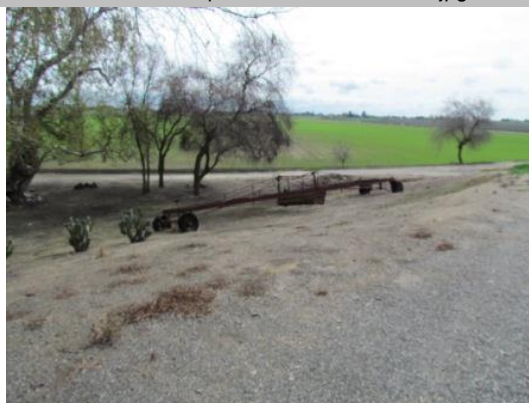
Photo 1 of 1 : pkazi\_s\_20140328\_691.jpg

Equipment was found on the landside of the levee looking downstream.

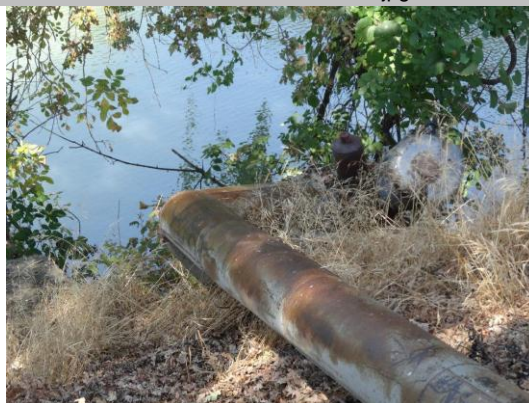
Photo 1 of 1 : UCIP\_2338.jpg

WS view: steel pipe and pump on levee slope.

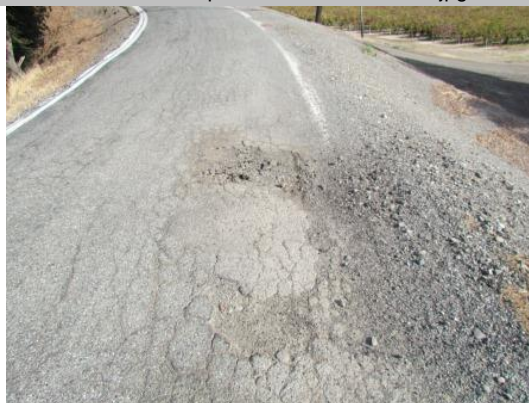
Photo 1 of 1 : pkazi\_s\_20140328\_697.jpg

Crown depression was found looking upstream during the fall 2013 inspection.

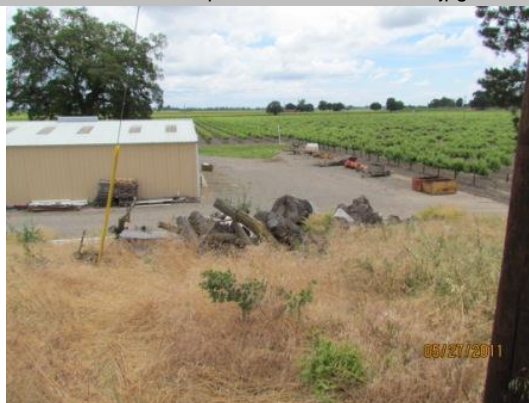
Photo 1 of 1 : pkazi\_s\_20140328\_654.jpg

Tree branches were found on the toe of landside of the levee. The picture was taken from the crown looking downstream.

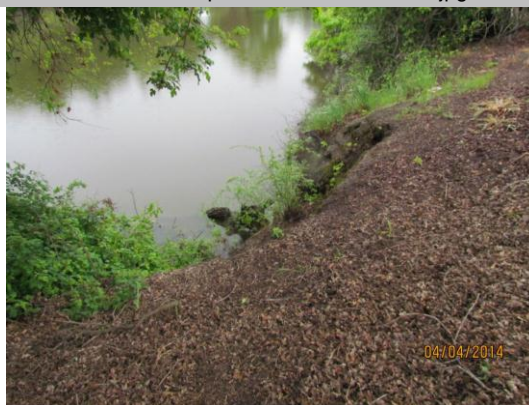
Photo 1 of 1 : pkazi\_s\_20140404\_077.jpg

View of an erosion on the waterside toe of the levee looking upstream.

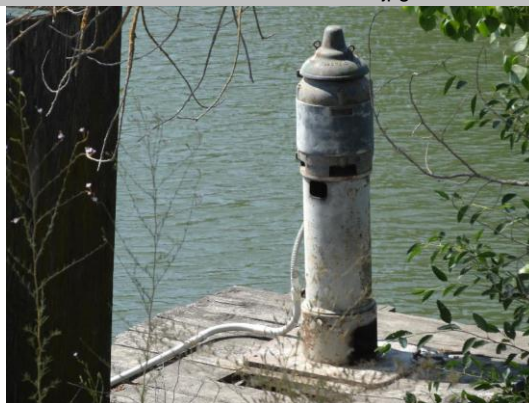
Photo 1 of 1 : UCIP\_1802.jpg

WS view: vertical pump on deck.

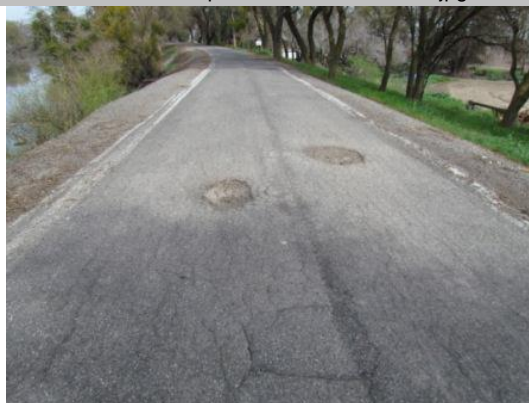
Photo 2 of 2 : pkazi\_s\_20140328\_669.jpg

Crown depressions were found during spring 2013 inspection looking upstream.

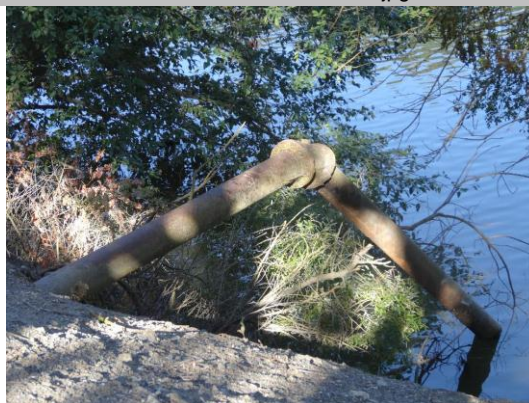
Photo 1 of 1 : UCIP\_1808.jpg

WS view: steel pipe on levee slope and in the stream.

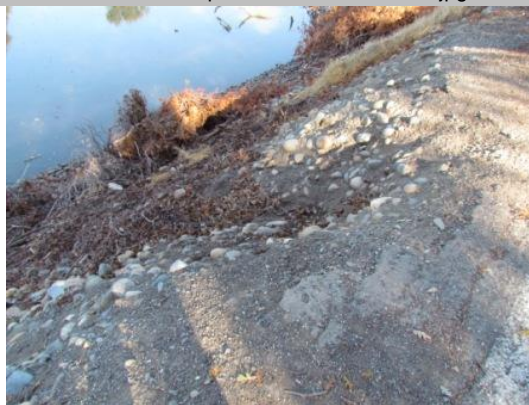
Photo 1 of 1 : pkazi\_s\_20140328\_636.jpg

Slope instability was found on the waterside of the levee looking upstream.

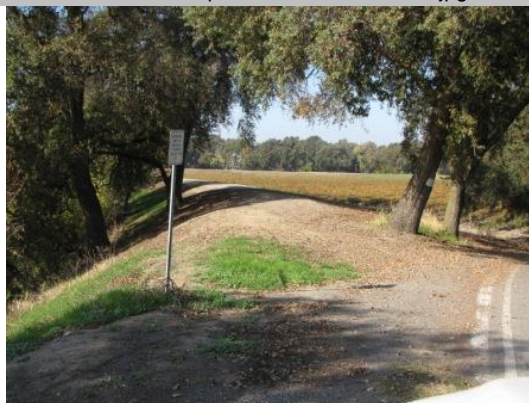
Photo 1 of 1 : pkazi\_s\_20140328\_709.jpg

View of varying elevations in the crown of the levee at the transition from county road to access road.

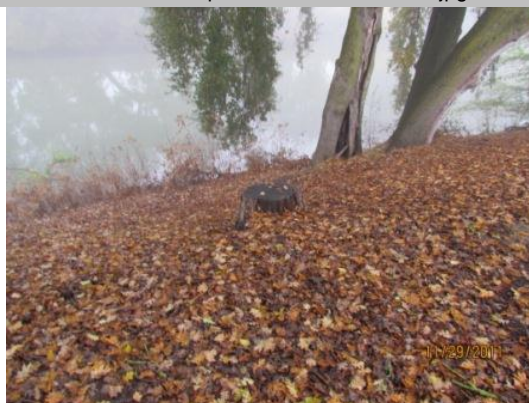
Photo 1 of 1 : pkazi\_s\_20140328\_673.jpg

Tree stump was found on the waterside of the levee looking upstream.

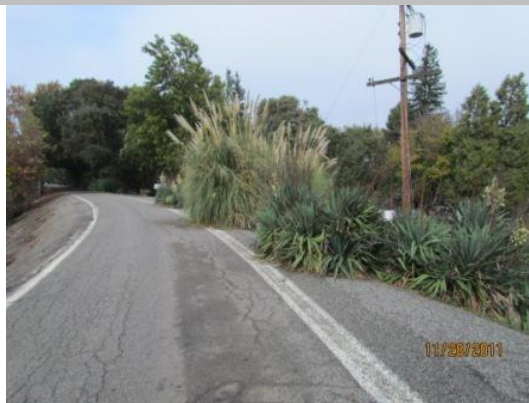
Photo 1 of 1 : pkazi\_s\_20140328\_624.jpg

Landscaping was found on the landside of the levee looking upstream.

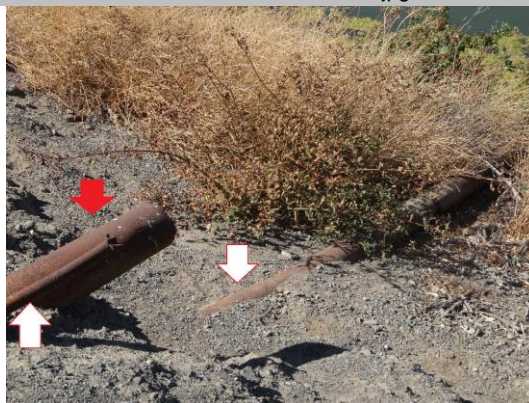
Photo 1 of 1 : UCIP\_1821.jpg

WS view: open ended 6" steel pipe (top-left), 1" steel pipe (bottom), and another 6" steel pipe (right) on levee slope.

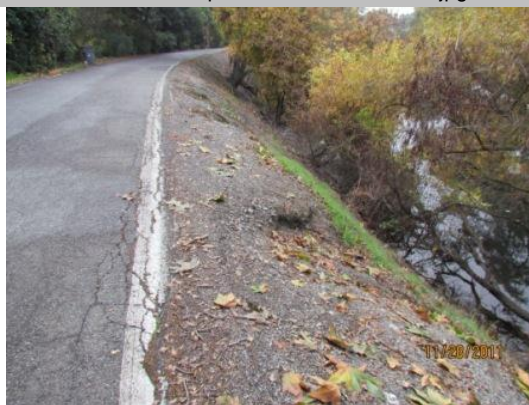
Photo 2 of 4 : pkazi\_s\_20140328\_662.jpg

Erosion was found on the waterside of the levee looking downstream. This picture was taken during fall 2011 inspection.

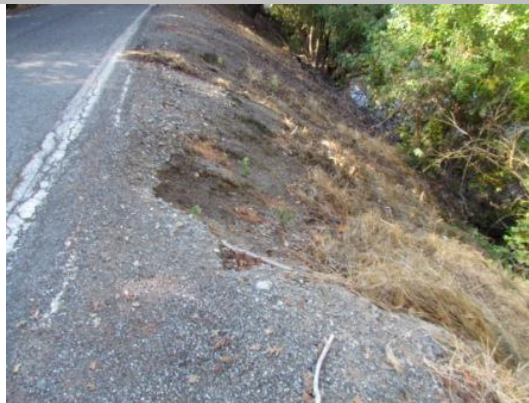
Photo 4 of 4 : pkazi\_s\_20140328\_664.jpg

Erosion was found on the waterside slope of the levee looking downstream. This updated picture was taken during fall 2012 inspection.

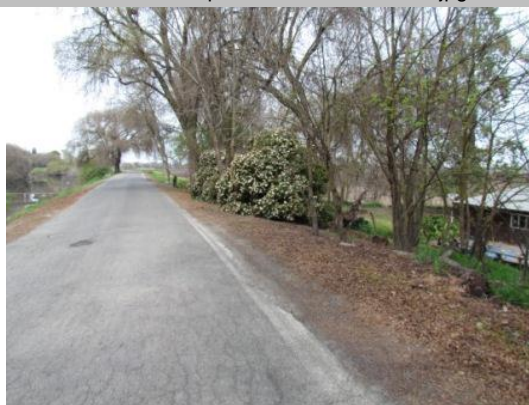
Photo 1 of 1 : pkazi\_s\_20140328\_630.jpg

Landscaping was found on the landside shoulder of the levee looking upstream.

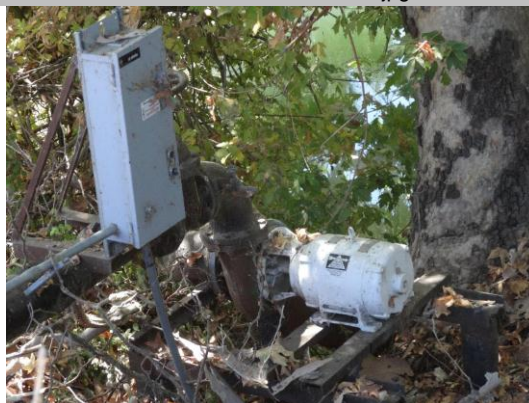
Photo 1 of 1 : UCIP\_2086.jpg

WS view: pipe and pump on levee slope.

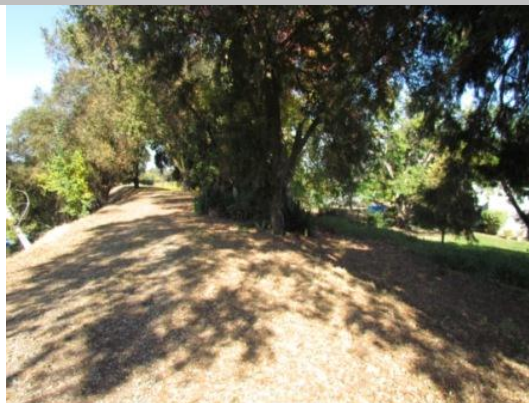
Photo 1 of 1 : pkazi\_s\_20140328\_685.jpg

Landscaping was found on the landside shoulder of the levee looking upstream.

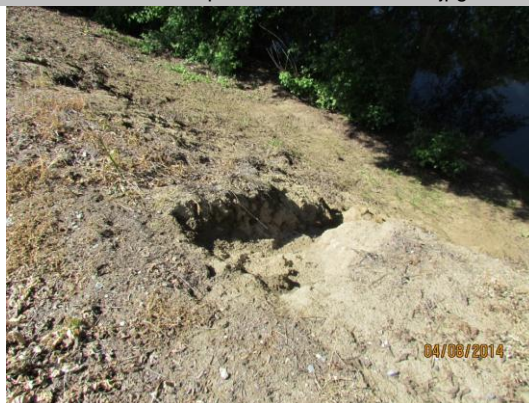
Photo 1 of 1 : pkazi\_s\_20140408\_080.jpg

A slope instability was found on the waterside of the levee looking downstream.

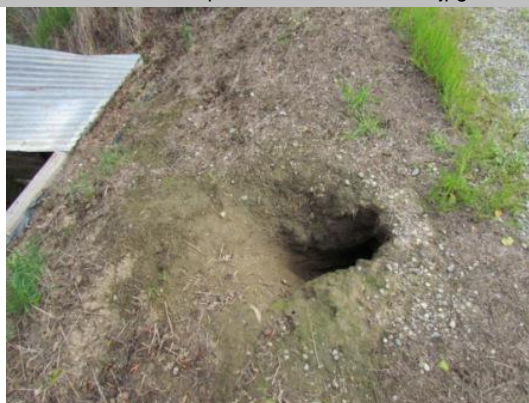
Photo 1 of 2 : pkazi\_s\_20140328\_687.jpg

A rodent hole was found on the waterside of the levee looking upstream.

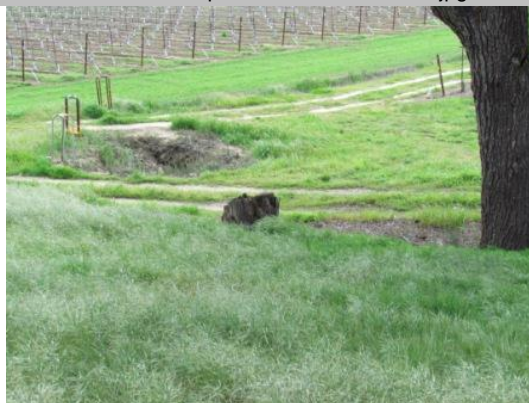
Photo 1 of 1 : pkazi\_s\_20140328\_689.jpg

A tree stump was found on the landside of the levee looking upstream.

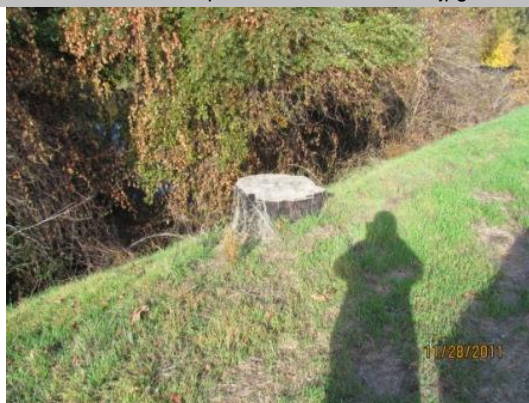
Photo 1 of 1 : pkazi\_s\_20140328\_655.jpg

A tree stump was found on the waterside of the levee looking upstream.
